**AVIATION INVESTIGATION REPORT**  
**A05C0123**

**IN-FLIGHT COLLISION**  
**BETWEEN**  
**WACO UPF-7 N2369Q AND**  
**WOLF-SAMSON N985PW**  
**MOOSE JAW, SASKATCHEWAN**  
**10 JULY 2005**

Report Number A05C0123

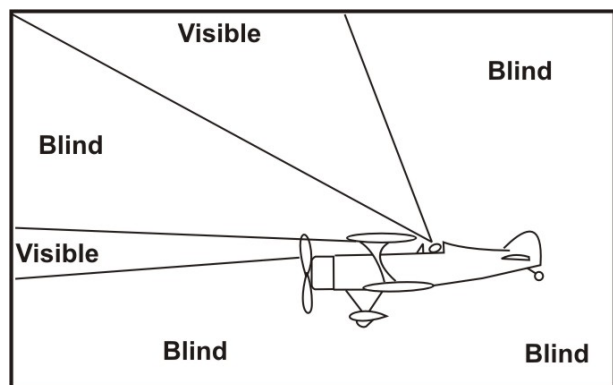
Figure 1. Blind spots for generic biplane

Both biplanes were highly manoeuvrable with ample power for the planned display. All aircraft have design limitations that restrict pilot visibility. Because the upper wing of biplanes is mounted ahead of and above the pilot, a significant additional blind spot is created in the pilot’s field of vision (see Figure 1). The blind spot was reduced in the Waco because of the cockpit modification. However, because of the inherent manoeuvrability of the two aircraft, the display pilots could quickly move the nose or wings out of the way to locate the other performers. Additionally, the aircraft were equipped with smoke generators. The display pilots used the smoke to quickly acquire the position of other performers. Temporary loss of visual contact between performers is considered acceptable when manoeuvres are flown as scripted because the performers know when and where visual contact will be regained. Manoeuvres must be planned so this temporary loss of contact does not compromise safety.

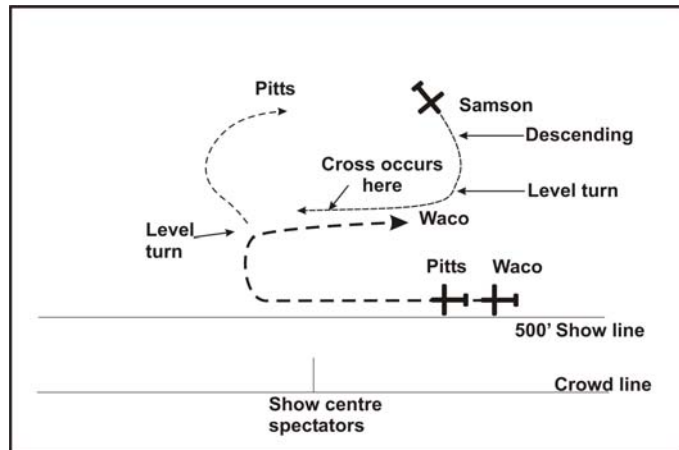
Figure 2. Original Dairy Turn

The Dairy Turn (see Figure 2) is a scripted manoeuvre that was flown immediately before a series of crosses and chases involving the jet-powered truck on the runway. From outside the 1500-foot show line at show right, the pilot of the Wolf-Samson begins a right descending turn with the intention of rolling out in the vicinity of and parallel to the 1500-foot show line. The pilot of the Pitts also enters from show right at low level along the 500-foot show line, chased closely by the Waco. Past show centre, the pilot of the Pitts makes a hard 90° turn, banking steeply to the right away from the spectators. He then makes another hard 90° turn to the left by using a pushing force on the control column, without changing the bank angle. The pilot of the

The Dairy Turn, as originally conceived and flown, had not caused problems when the Waco was too far behind the Pitts because the Waco turned between the Wolf-Samson and the spectators. This resulted in flight paths that did not cross and gave the pilot of the Waco visual contact with the Wolf-Samson or its smoke during the second 90° turn. While this variation of the manoeuvre gave the crowd the illusion of danger, safety was readily controlled by the performers.

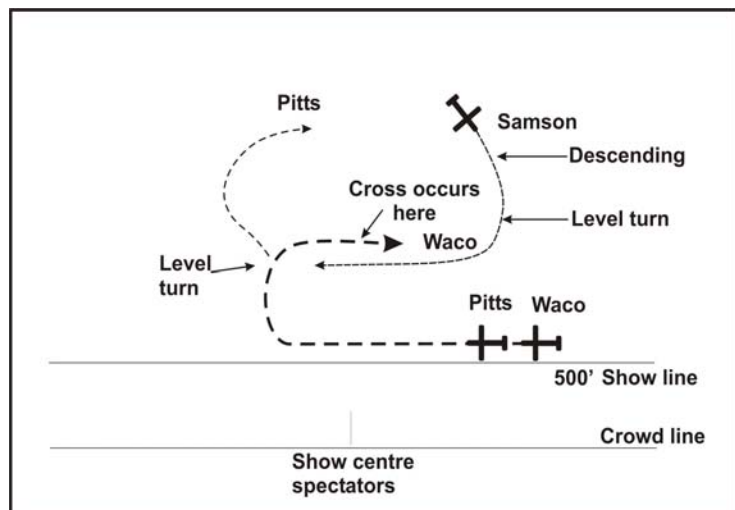
Figure 3. Modified Dairy Turn

Information gathered during the investigation indicated that the cross had been recently modified (see Figure 3). In this variation, the Waco flies across the projected path of the Wolf-Samson before making the hard right turn. The modified cross occurs when the two biplanes pass with the Wolf-Samson between the Waco and the spectators. A videotape of a recent display by the performers shows that the manoeuvre had been modified. Whether the contract for safe separation was also revised could not be established.

The modified Dairy Turn, however, resulted in flight paths that crossed twice resulting in two points of possible collision (see Figure 3). The first point of possible collision was more dangerous because the tracks intersected at 90°, with the potential for both aircraft to be banked away from the other. Because of the manoeuvre’s timing, it was critical for either pilot to obtain visual contact with the other pilot. As shown in Figure 3, the manoeuvre becomes dangerous if the Waco is a few seconds late. This is a significant difference from the original manoeuvre, and the risk of collision was no longer just an illusion. The modified manoeuvre did not ensure safe execution unless at least one of the pilots had visual contact with the other. Because of the increased risk, the two pilots should have ensured that a clearly understood contract was in place.

1. The Dairy Turn manoeuvre had been modified such that a temporary loss of visual contact could occur immediately before the aircraft crossed flight paths. This modification made timing critical and added two potential points of collision.
2. The manoeuvres immediately before the collision indicated that the performers had not established a clearly understood contract for the revised manoeuvre. The actions of each performer negated the actions of the other, and neither pilot took positive action to regain visual contact.
3. The timing of the manoeuvre was lost when the Waco turned late at show centre.

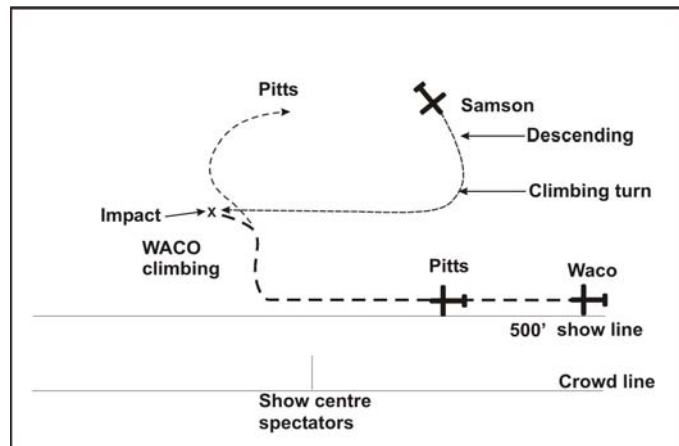
Figure 4. Accident sequence

The pilot of the Wolf-Samson flew a right-hand turn toward the spectators from outside the 1500-foot show line from show right (see Figure 4). As he approached the 1500-foot show line, he began a climb while maintaining the bank angle. The climb was maintained until impact. He made no radio transmission indicating that he was climbing. Further, there was no movement of the aircraft that would have indicated an attempt to visually acquire the Waco and ensure separation. Close scrutiny of several videotapes of the turn show that the pilot of the Wolf-Samson was in a position to see the Pitts cross show centre and break right without the Waco in close proximity. However, the videotapes also indicate that it would have been impossible for the pilot of the Wolf-Samson to see the Waco in the last 90 degrees of turn without movement of the biplane's wings or nose.

The pilot of the Waco entered from show right chasing the Pitts down the 500-foot show line (see Figure 4). In the vicinity of show centre, he made a hard 90° turn away from the spectators, following the Pitts. However, he was significantly behind the Pitts. He then banked steeply to the left, entering a climb. He maintained a steep bank angle and the aircraft started to turn to the left as the jet engine was heard to increase in power. Videotapes show that once the bank to the left was started, the pilot of the Waco could not have seen the Wolf-Samson. The bank was maintained until impact. As with the pilot of the Wolf-Samson, there was no radio transmission from the pilot of the Waco and no movement of the aircraft that would have indicated an attempt to visually acquire the other performer and ensure separation.

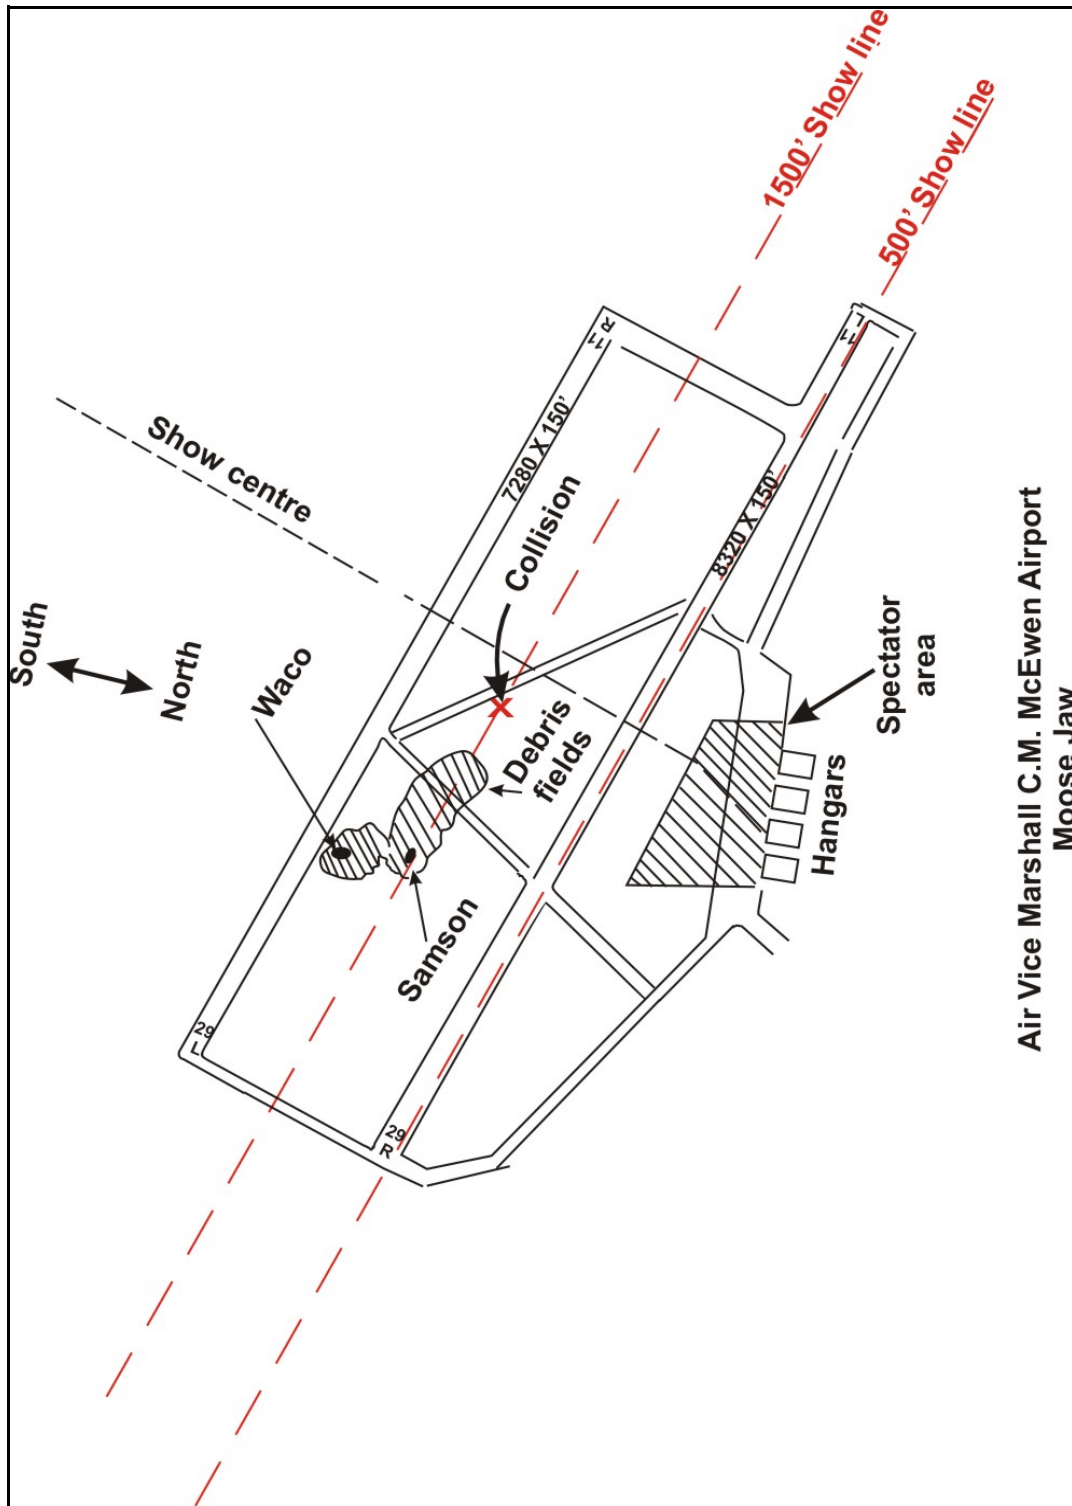
Appendix A – Air Vice Marshall C.M. McEwen Airport,  
Moose Jaw, Saskatchewan

The debris field is indicated on Appendix A. It began about 200 to 300 feet left of show centre outside the 1500-foot show line. Debris from the Wolf-Samson indicates that its flight path was at a shallow angle to the 1500-foot line. Debris from the Waco indicates that it had begun to turn to the left away from the Wolf-Samson. The debris trail of the Waco was about 1200 feet long. One blade of the Wolf-Samson's propeller was imbedded in the spinner of the Waco, which, in conjunction with videotape information, indicates that the two biplanes were belly to belly at impact.

The length of the debris field of the Waco indicates that there was sufficient energy after the collision for debris to have reached the spectator area if the energy vector had been directed toward the show line. The Dairy Turn was not described in the sequential list, and its potential for an inappropriate energy vector could not have been properly evaluated. While it is unlikely that the Dairy Turn would have resulted in such a vector, the debris field clearly indicates the importance of a critical review by TC of the sequential list of manoeuvres during the SFOC approval process. The limited information provided for the other manoeuvres in the sequential list would have also precluded an assessment of energy management.
